High density PCB technology for high reliability applications using Low CTE material

- Joachim Verhegge, ACB, Dendermonde, Belgium
- Jean-Claude Fabre, SAFRAN Electronics & Defense, Châteauneuf-sur-Isère, France
- Thomas Löher, TUB, Berlin, Germany
- Nadia Ibellaatti, NANOXPLORE, Sèvres, France

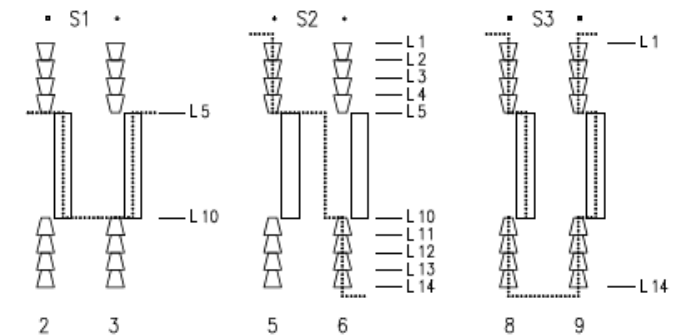
Graph of S2 for coupon SLX14256A
350um buried
4 levels of 125um μ -vias stacked

- 32 SLX coupons with 6 different configurations tested
- 30 coupons passed
(1 coupon had a damaged connector and 1 coupon failed without rootcause)
- Maximum 0.2% resistance increase after an additional 500 cycles at 190°C for the microvias (S2)

- There is no observable difference between the different configurations and the stacked microvias can be considered as reliable as the staggered configuration.
- No observed difference in reliability between the 150 μ m and 125 μ m laser drill diameters.
- Overall, it can be concluded that the HDI technology using low CTE material show an exceptionally high reliability during IST testing

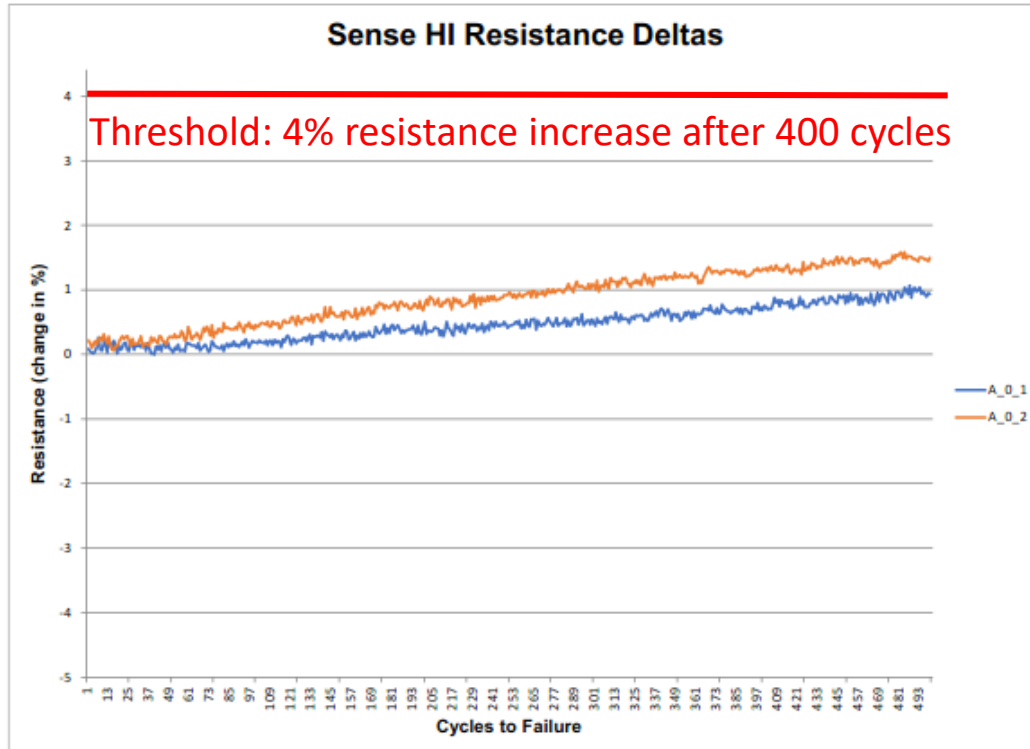
PI Staggered μ -via configuration

- A reference batch with the same design and μ -via configurations was manufactured to have a direct comparison between the PI and Low-CTE material.
- Only IST testing was performed to assess the reliability of the PI build.
- 2 tested TVX coupons showed a good reliability of the PTHs with a maximum resistance increase of 0.4% after 500 cycles at 170°C
- All tested pairs of coupons of the stacked and semi stacked configurations failed before the microvia cycling
- The 2 SLX14260A coupons with a fully staggered microvia configuration did pass both buried via and microvia cycling. A resistance increase of 1.5% was observed after 500 cycles at 210°C
- Since all stacked configurations failed the LOW-CTE material has proven much more reliable for this complex HDI configuration
